# The Slippery Slope of Litigating Geologic Hazards: California's Portuguese Bend Landslide

David L. Ozsvath

## Part II – Landslide

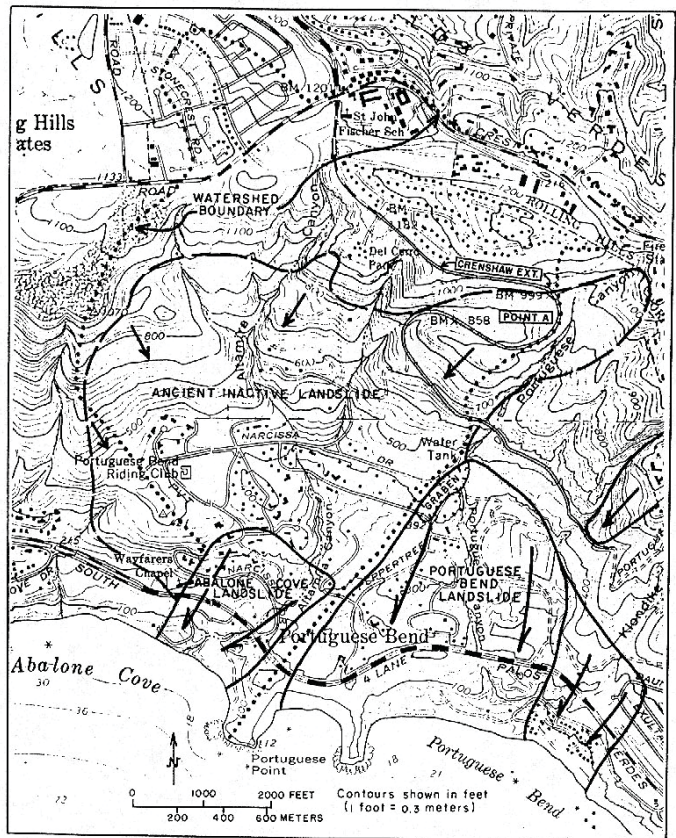
Figure 2. Portuguese Bend, Topographic Map

Figure 2  
Site Map of the Portuguese Bend and Abalone Cove Landslides

Land use on the Palos Verdes Peninsula (see Figure 1) consists mostly of single-family homes built on large lots, many of which have panoramic ocean views. The affluent residents of this area value a rural lifestyle, and the peninsula is zoned to permit horses, stables and riding trails. Figure 2 is a topographic map showing the Portuguese Bend area.
