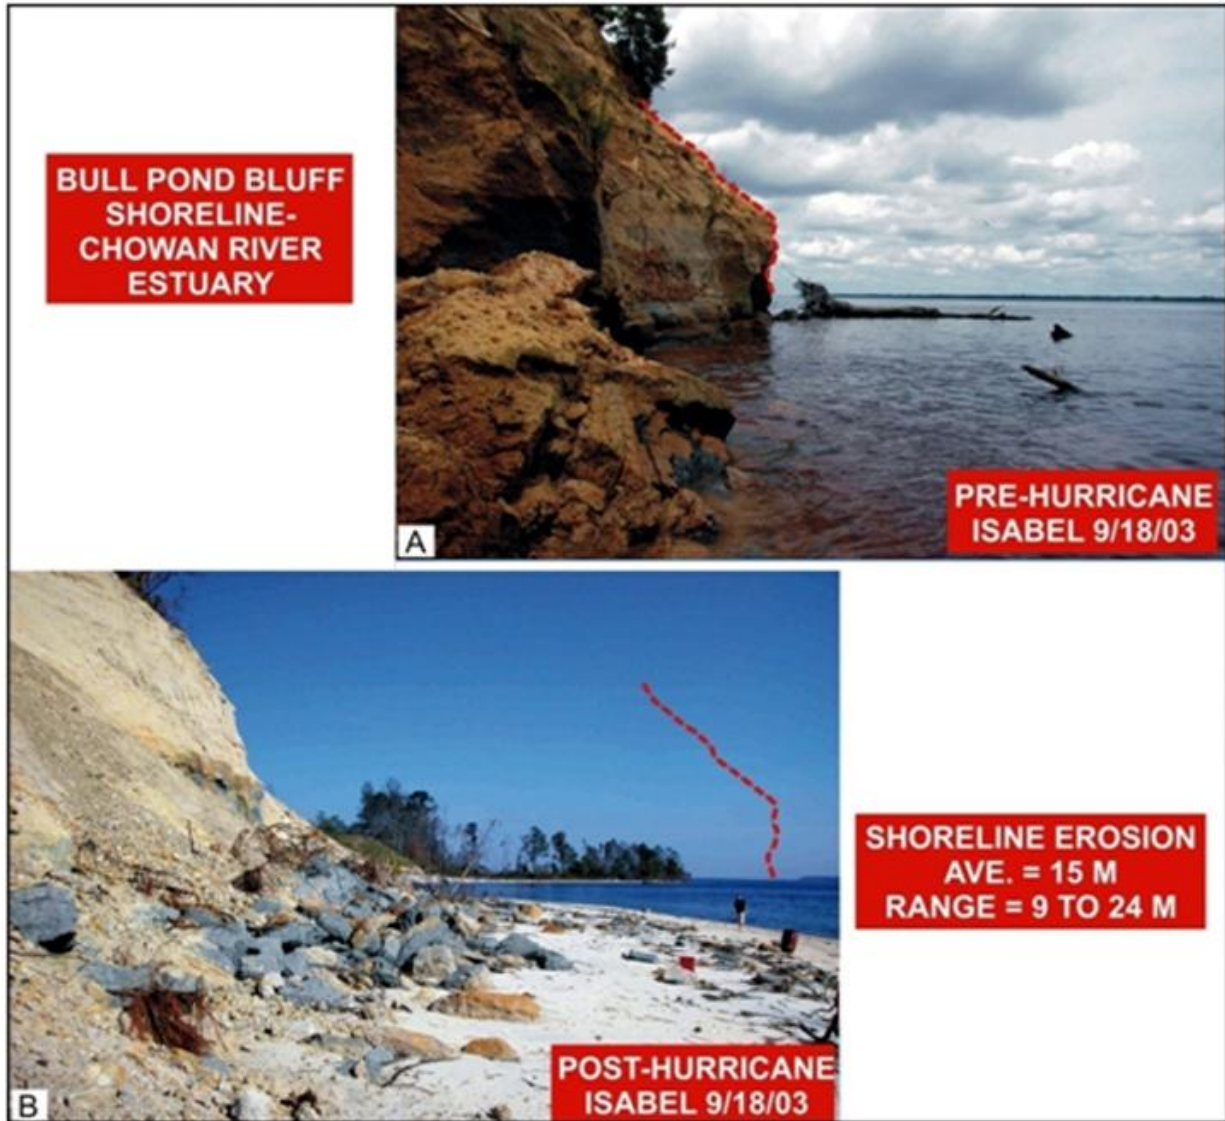
Figure 1-30

Figure 1-30. Two photographs of an eroding estuarine sediment-bank shoreline along the western side of the Chowan River. Panel A: Pre-Hurricane Isabel photograph was taken prior to the storm on September 18, 2003. This ~75-foot high bluff consists of a lower clay bed (~30 feet thick) with an overlying sand bed (~45-50 feet thick). Panel B: The post-Hurricane Isabel photograph was taken on October 6, 2003 from about the same location along the bluff shoreline as Panel A. The red dashed line in Panel A is in the same relative location as in Panel B. The average bluff shoreline recession was about 50 feet (range from about -30 to -80 feet) for the several segments of accessible bluff shoreline. Figures are the front and back cover of Riggs and Ames (2003).
